DUSTFALL AND SNOW SAMPLING SURVEY

JAMES RIVER–MARATHON LIMITED
MARATHON, 1985–86

Ministry of the Environment
Ontario

January, 1987

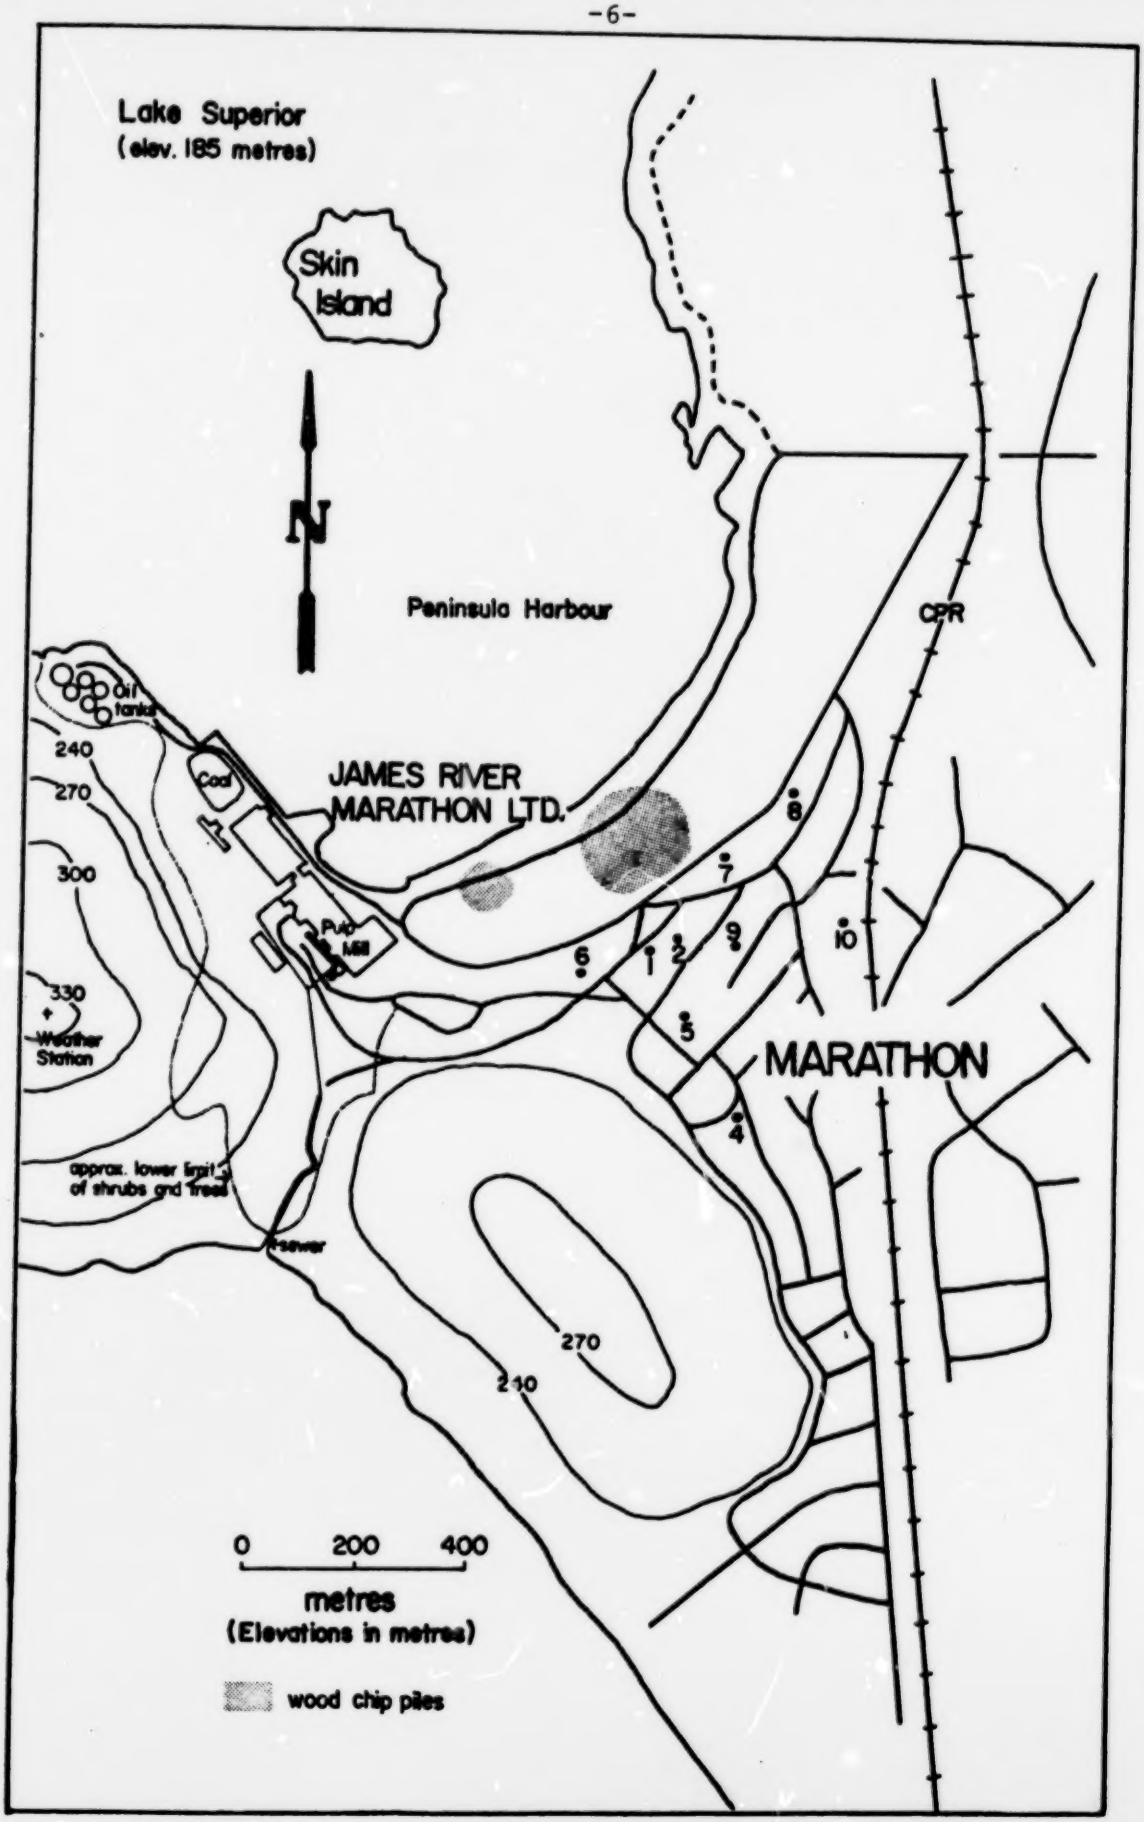
Figure 2. Snow sampling sites, Marathon, January, 1986.

Concentrations of particulate carbon and residues (solids) were significantly elevated near the chip piles and decreased as distance from the piles increased. Their distribution pattern was similar to that shown in Figure 3 for suspended solids. The guideline for suspended solids (30 mg/ℓ) was exceeded at all sampling locations and was in the 125 to 150 mg/ℓ range near the apartment buildings (sites 1 and 2, Figure 2) from which complaints originated.

Trace to moderate quantities of wood fines and black particulate matter (wood or bark char) were visible in snow at all sites except the controls. Microscopic examination determined that at sites 1 and 2 near the apartments, wood fibres accounted for 97-98% of the suspended solids. At the greatest distance sampled from the chip piles (sites 4 and 10) wood fibres still comprised 85-90% of suspended solids.
